This ball joint is a stock OEM replacement for a number of Chrysler products. It has a wear indicator that the zinc fitting threads into. Once this button is flush with the flat surface around it the ball joint needs to be replaced.

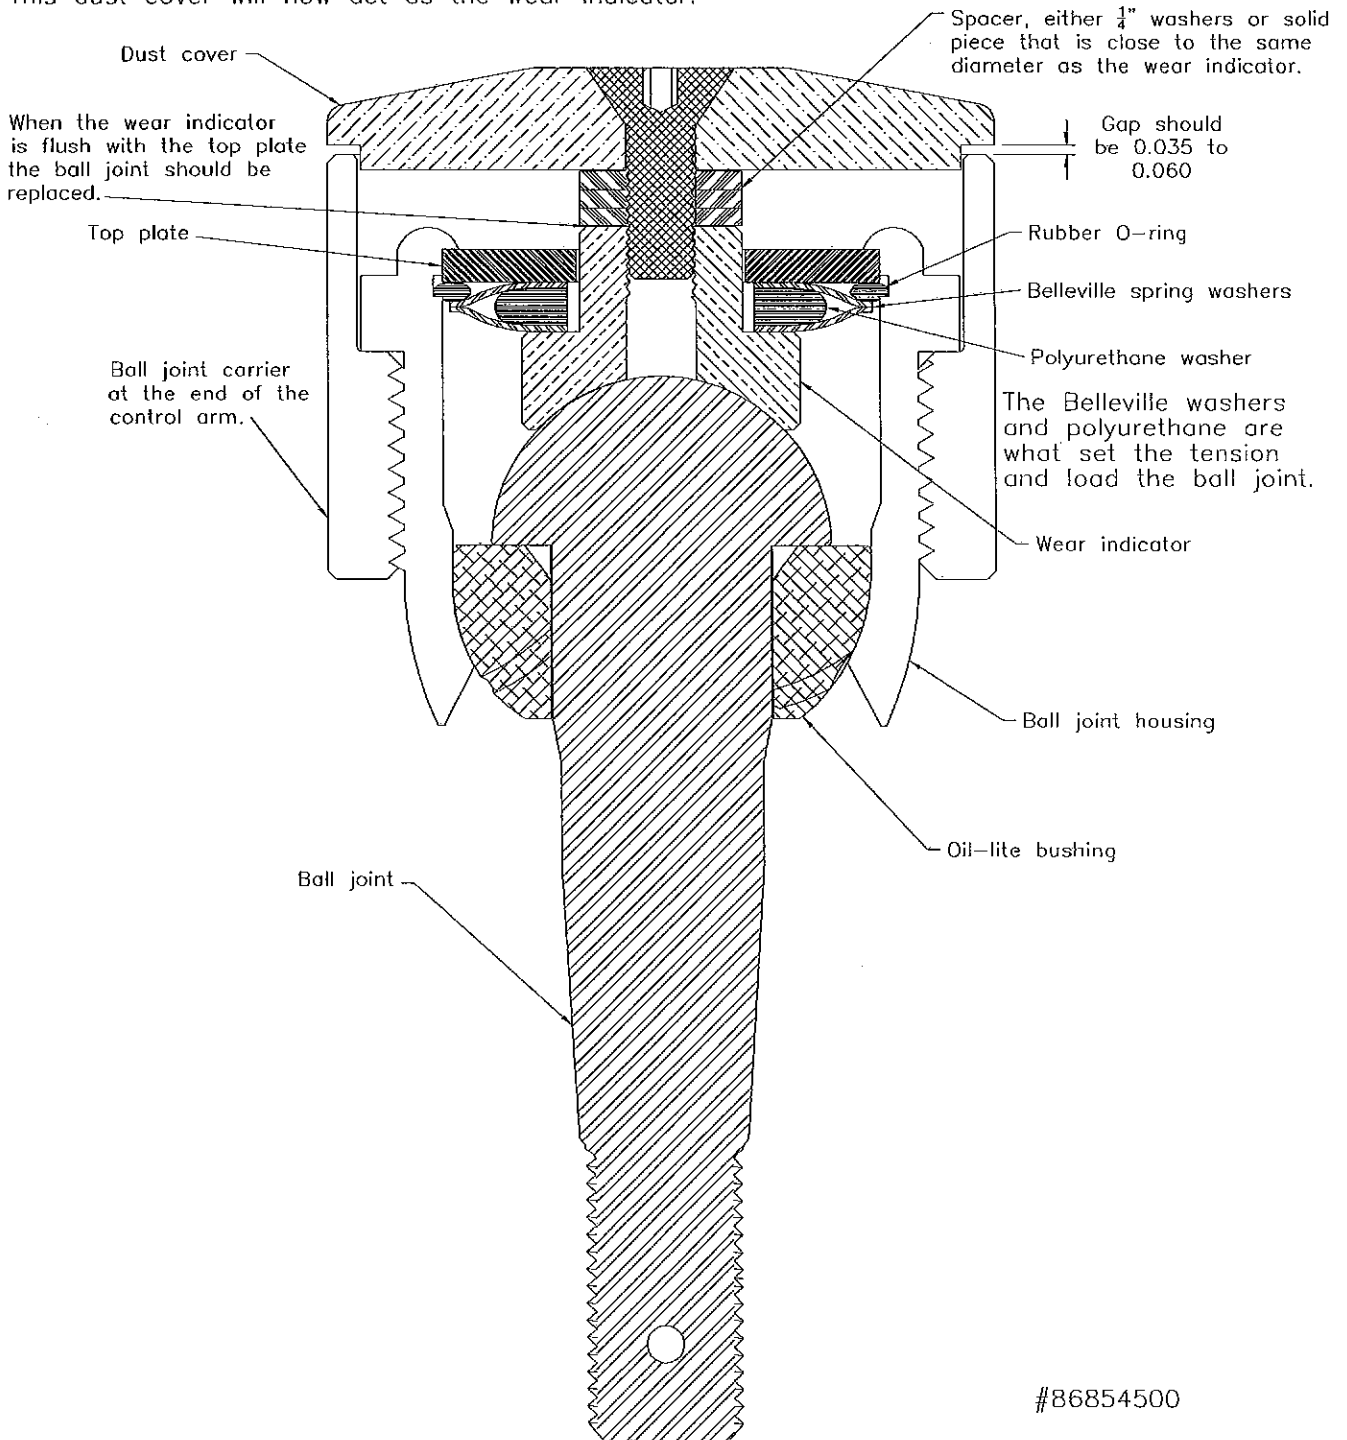
The drawing is a cross section of the ball joint installed with the dust cover in place. If the dust cover is bolted in place without a spacer between the wear button and the cover the ball joint will be loose because the countersunk screw pull the button away from the ball. The dust should have a gap between the pocket it fits into and the dust cover. The gap should be between .030 to .060. This dust cover will now act as the wear indicator.

If this ball joint is used on a Morrison IFS and a dust cover is set in place after the ball joint is lubricated follow these instructions.
